**Flood Control Project Maintenance
Levee Inspections**
LMA District Cover Sheet
Spring 2018 Levee Inspection Results

Levee District No. 0002 (Glenn County)

Levee Inspection Report By Mile - Spring 2018

Waterway	Bank	Unit Miles	Inspection Start/End	Inspector
Unit No. 01 Glenn County Sacramento River	Right	4.90	03/07/2018 03/07/2018	Bob Duffey

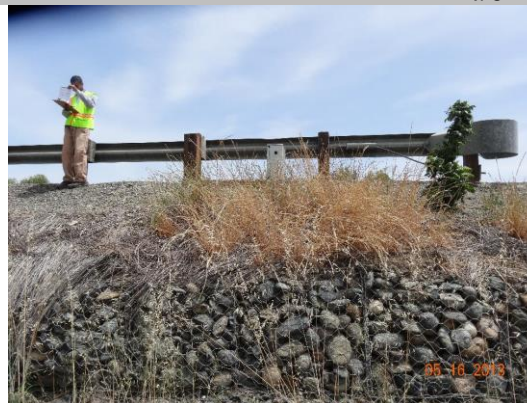
Photo 1 of 3 : UCIP_SP_2018_42083_72882.jpg

LM Start	0.59	Rating **	M	Issue No.	53	
LM End	0.59	Issue Type +	En	Location *		
Category	Supplemental			GPS Latitude/Longitude		
				Start	End	
Item	DWR UCIP Field Study			39.422088 °	39.422088 °	
				-122.011615 °	-122.011615 °	
DWR ID						
Comment Code						
Inspector Comment						
FS_ID:42083						
DS_ID:24877						
EP_NO: N/A						
Repair Type: Non-Urgent						
Crossing Status: Indicator Found						
UCIP Comments: Need to contact owner to determine if conduit goes through levee crown. If it does, will need to obtain permit number issued for encroachment.						
FIELD_STRUCT_DESC: Caltrans traffic control box located on the landside (LS) shoulder.						
FS Date: 5/16/2013

View of landward slope.

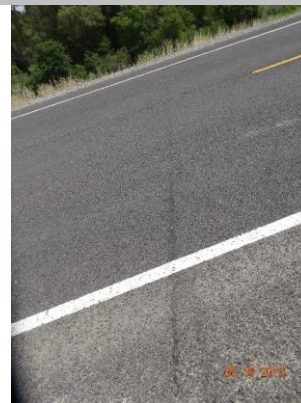
Photo 2 of 3 : UCIP_SP_2018_42083_72881.jpg

View of levee crown at crossing.

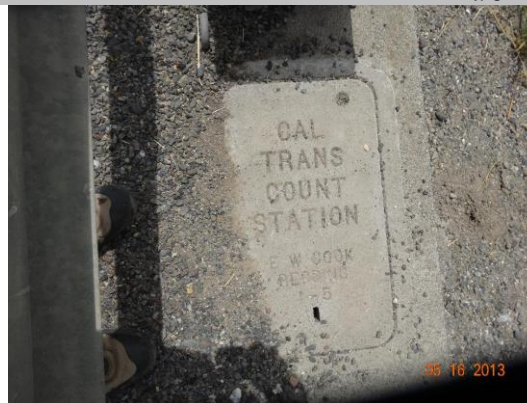
Photo 3 of 3 : UCIP_SP_2018_42083_72880.jpg

LM Start	0.59	Rating **	M	Issue No.	53 (cont)	
LM End	0.59	Issue Type +	En	Location *		
Category	Supplemental			GPS Latitude/Longitude		
				Start	End	
Item	DWR UCIP Field Study			39.422088 °	39.422088 °	
				-122.011615 °	-122.011615 °	
DWR ID						
Comment Code						
Inspector Comment						
FS_ID:42083						
DS_ID:24877						
EP_NO: N/A						
Repair Type: Non-Urgent						
Crossing Status: Indicator Found						
UCIP Comments: Need to contact owner to determine if conduit goes through levee crown. If it does, will need to obtain permit number issued for encroachment.						
FIELD_STRUCT_DESC: Caltrans traffic control box located on the landside (LS) shoulder.						
FS Date: 5/16/2013

Service box located on landward shoulder.

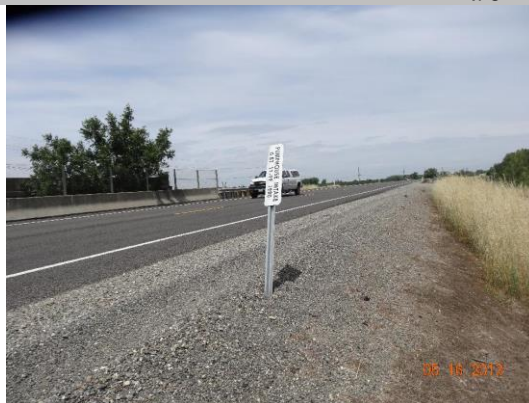
Photo 1 of 3 : UCIP_SP_2018_38165_69467.jpg

UCIP Comments: Three pipes found in the pump house on landward side. Pump house appears to be no longer in use. Unable to locate pipes on waterward side. Will need to contact owner to determine status. Owner will need to coordinate with CVFPB regarding proper removal per Title 23 requirements.

View of levee crown at crossing.

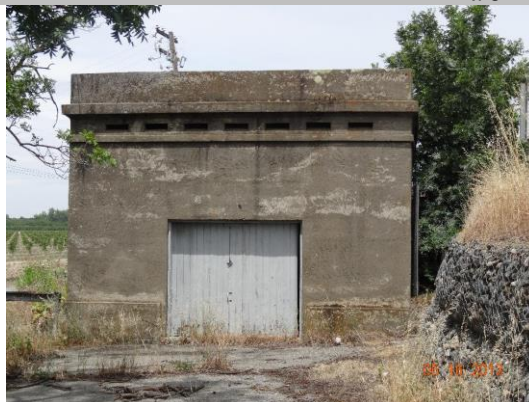
Photo 2 of 3 : UCIP_SP_2018_38165_69469.jpg

View of Princeton-Cordora-Glenn Irrigation District--Schaad Pumping Plant.

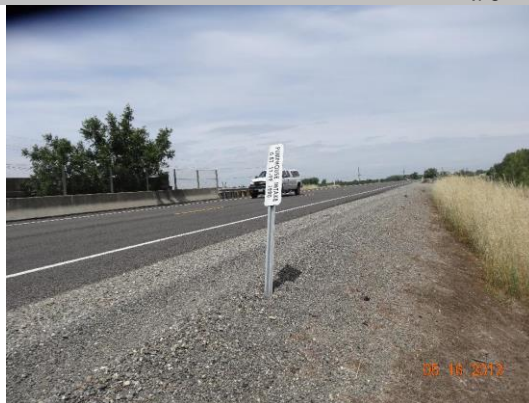
Photo 1 of 3 : UCIP_SP_2018_38168_69491.jpg

Comment Code					
Inspector Comment					
FS_ID:38168 DS_ID:21182 EP_NO: N/A Repair Type: Non-Urgent Crossing Status: Indicator Found UCIP Comments: Unable to verify if the pipes inside the existing pump house correlate to 24-inch installed in 1955. Three pipes found in the pump house on landward side. Pump house appears to be no longer in use. Unable to locate pipes on waterward side. Will need to contact owner to determine status. FIELD_STRUCT_DESC: [Pumping Plant] 24-inch steel pipe through the levee, 27.3 feet below the crown. Flap gate on landside (LS). Pump in pump house on LS. [Additional Reference(s): DWR Levee Logs, 2005. USACE Sacramento O&M Manual Unit No. 151, November 1953, (Station 41+47), 24-inch pipe] FS Date: 5/16/2013

View of levee crown with marker on waterward side.

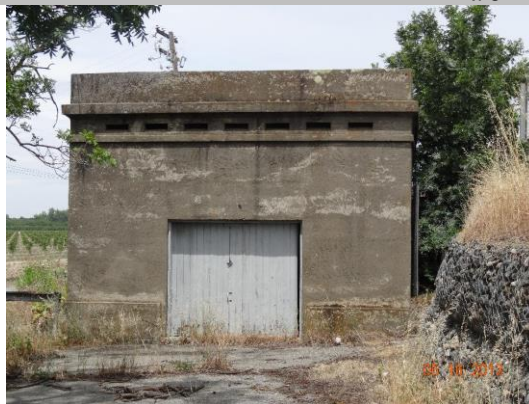
Photo 2 of 3 : UCIP_SP_2018_38168_69493.jpg

View of Princeton-Cordora-Glenn Irrigation District-Schaad Pumping Plant.

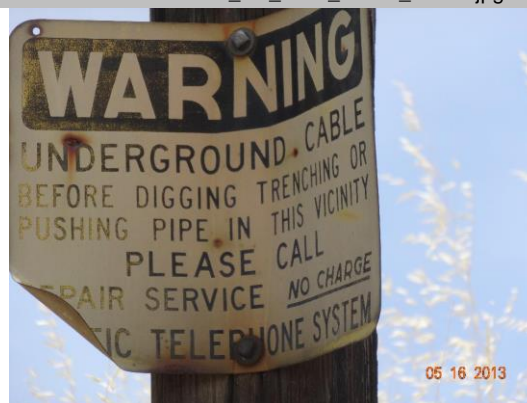
Photo 3 of 3 : UCIP_SP_2018_44170_72600.jpg

Comment Code						
Inspector Comment						
FS_ID:44170 DS_ID:21177 EP_NO: 9723 Repair Type: Non-Urgent Crossing Status: Indicator Found UCIP Comments: Owner is listed as Pacific Bell however sign lists AT&T as owner, need to contact owner to determine if permit was updated or if this crossing is listed under new permit. Unable to confirm if 2 crossings are present at this site. FIELD_STRUCT_DESC: Buried telephone cable through the levee at unknown depth. Telephone pole and junction box on landside (LS) toe. (telephone cable authorized under Automatic Board Order (ABO) issued as Permit No. 9723-1974, Pacific Telephone Company). FS Date: 5/16/2013

Sign lists Pacific Telephone system.

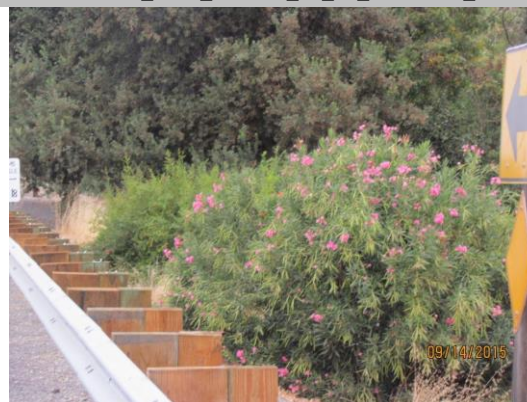
Photo 1 of 1 : SP_2018_LD0002_28_30_20180305_00016.jpg

LM Start	1.03	Rating **	M	Issue No.	30
LM End	1.03	Issue Type +	En	Location *	WS
Category	Earthen Levee			GPS Latitude/Longitude	
				Start	End
Item	Vegetation			39.428445 °	39.428445 °
				-122.010972 °	-122.010972 °
DWR ID	DWR_LD0002_01_f_2015_30				
Comment Code					
V6 : Landscaping					
Inspector Comment					
Remove the oleanders from the waterside slope.

View of the oleanders along the waterside slope.

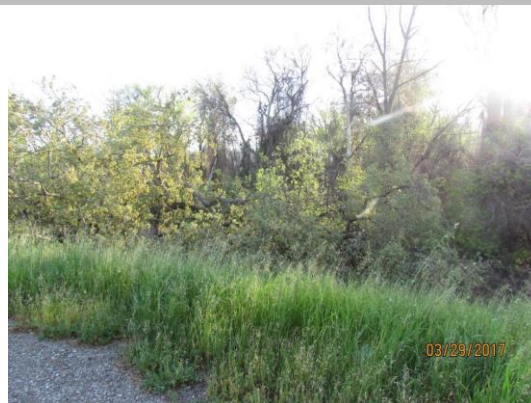
Photo 1 of 1 : SP_2018_LD0002_28_29_20180305_00015.jpg

View of the tree on the water side slope and toe.

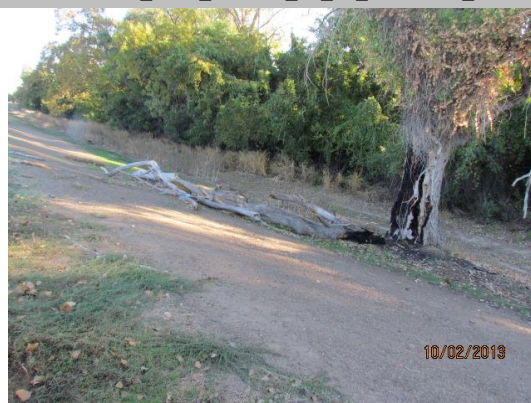
Photo 1 of 2 : SP_2018_LD0002_28_40_20180305_00021.jpg

LM Start	1.24	Rating **	M	Issue No.	40
LM End	1.24	Issue Type +	Ma	Location *	WS
Category	Earthen Levee			GPS Latitude/Longitude	
				Start	End
Item	Encroachments			39.431499 °	39.431499 °
				-122.010803 °	-122.010803 °
DWR ID	DWR_LD0002_01_f_2013_40				
Comment Code					
TR : Tree or limb					
Inspector Comment					
Remove the tree limbs from the waterside slope.

View of the downed tree limb along the slope of the levee.

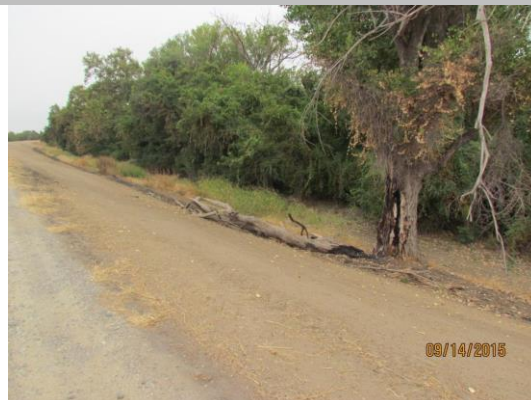
Photo 2 of 2 : SP_2018_LD0002_28_40_20180305_00022.jpg

View of the tree limbs along the waterside slope.

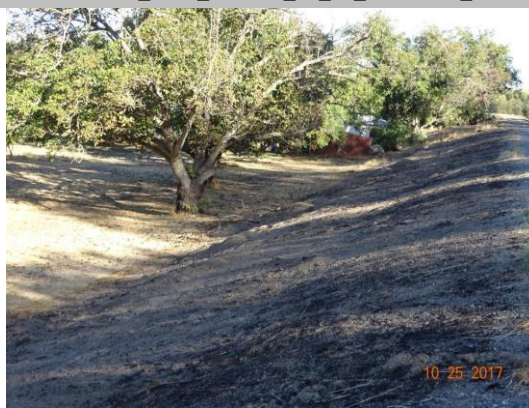
Photo 1 of 2 : SP_2018_LD0002_28_15_20180305_00009.jpg

LM Start	1.52	Rating **	U	Issue No.	15
LM End	1.60	Issue Type +	Ma	Location *	LS
Category	Earthen Levee			GPS Latitude/Longitude	
				Start	End
Item	Animal Control			39.435485 °	39.436643 °
				-122.010640 °	-122.010498 °
DWR ID	DWR_LD0002_01_f_2012_15				
Comment Code					
A3 : No rodents visible, but rodent burrows visible; need to backfill and compact or grout burrows.					
Inspector Comment					
Repair the rodent holes along the landside slope.

View of the rodent holes along the landside slope.

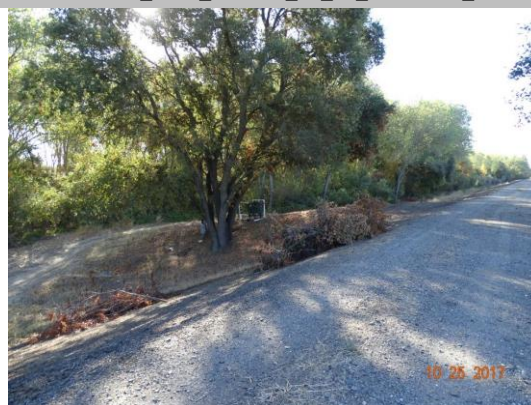
Photo 1 of 1 : SP_2018_LD0002_28_32_20180305_00018.jpg

View of the prunings along the waterside slope.

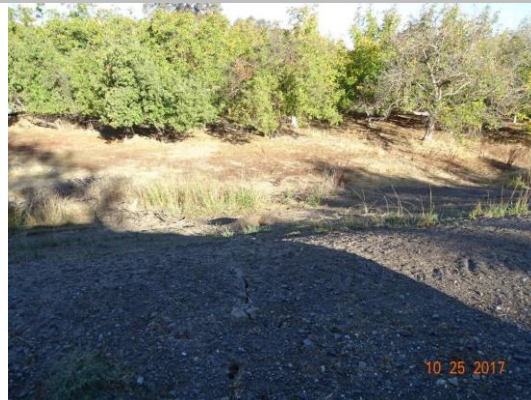
Photo 1 of 2 : SP_2018_LD0002_28_2_20180305_00001.jpg

LM Start	2.91	Rating **	U	Issue No.	2
LM End	2.96	Issue Type +	Ma	Location *	LS
Category	Earthen Levee			GPS Latitude/Longitude	
				Start	End
Item	Animal Control			39.453595 °	39.454003 °
				-122.016273 °	-122.015503 °
DWR ID	DWR_LD0002_01_f_2015_2				
Comment Code					
A3 : No rodents visible, but rodent burrows visible; need to backfill and compact or grout burrows.					
Inspector Comment					
Repair the rodent holes along the landside slope.

View of the rodent holes along the landside slope.

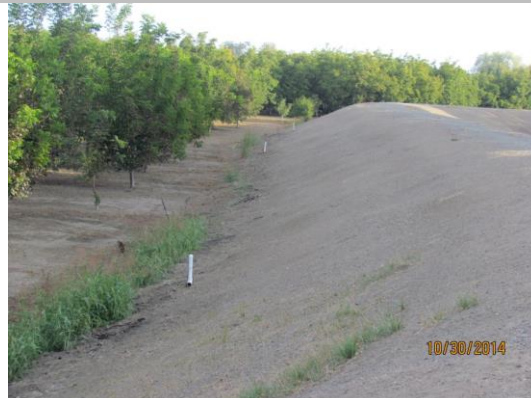
Photo 2 of 2 : SP_2018_LD0002_28_2_20180305_00002.jpg

View of the rodent holes and bait station along the landside slope.

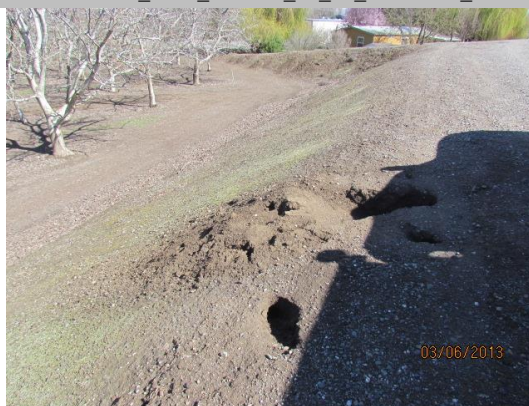
Photo 1 of 1 : SP_2018_LD0002_28_12_20180305_00007.jpg

LM Start	3.11	Rating **	U	Issue No.	12
LM End	3.16	Issue Type +	Ma	Location *	LS
Category	Earthen Levee			GPS Latitude/Longitude	
				Start	End
Item	Animal Control			39.455647 °	39.456004 °
				-122.013623 °	-122.012776 °
DWR ID	DWR_LD0002_01_s _ 2013_12				
Comment Code					
A1 : Exterminate rodents and backfill and compact or grout burrows.					
Inspector Comment					
Repair the rodent holes along landside slope.

View of the rodent activity along the landside slope.

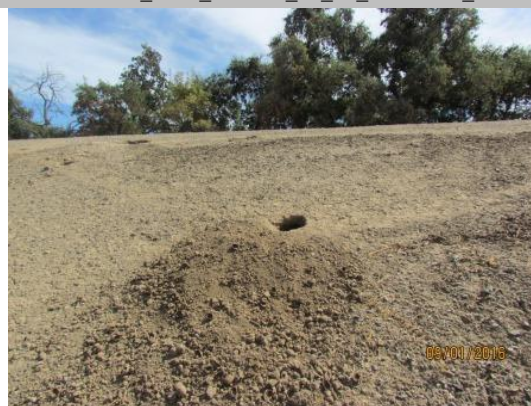
Photo 1 of 2 : SP_2018_LD0002_28_16_20180305_00011.jpg

View of the rodent holes along the landside slope.

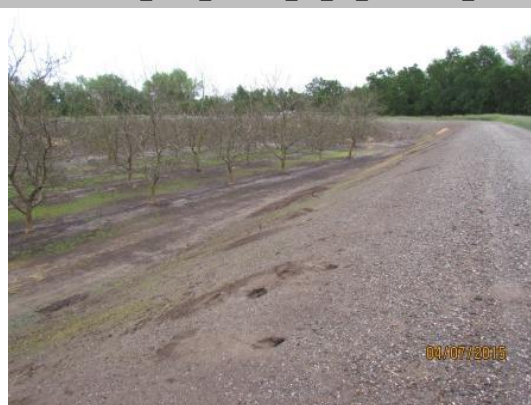
Photo 2 of 2 : SP_2018_LD0002_28_16_20180305_00012.jpg

View of the rodent holes along the landside slope.

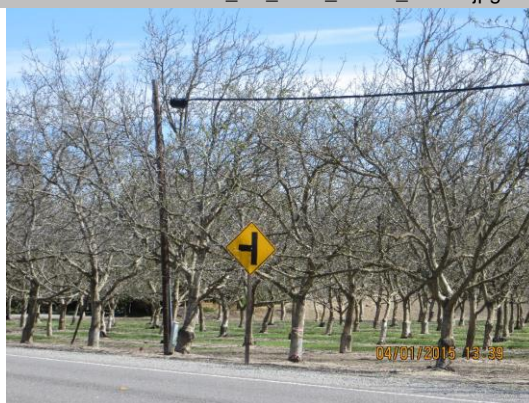
Photo 1 of 2 : UCIP_SP_2018_44185_73608.jpg

Comment Code						
Inspector Comment						
FS_ID:44185 DS_ID:21175 EP_NO: 5376 Repair Type: Non-Urgent Crossing Status: Indicator Found UCIP Comments: Conduit needs markers ten feet off both levee toes. FIELD_STRUCT_DESC: Three 3.5-inch steel cables sleeved through conduit through the levee, 3 feet below the crown. Metal cutoff wall around conduits near center of levee. Conduits are welded to the cutoff wall, extending only between the levee shoulders under the crown. Cut in pavement visible at crown. Cables extend to pole on waterside (WS). (replace existing aerial telephone cables with two buried cables authorized under Permit No. 5376, 1967-Pacific Telephone & Telegraph Co.) [Additional Reference(s): DWR Levee Logs, 2005] FS Date: 4/1/2015

Conduit may be visible at pole about 1000-feet west of crown.

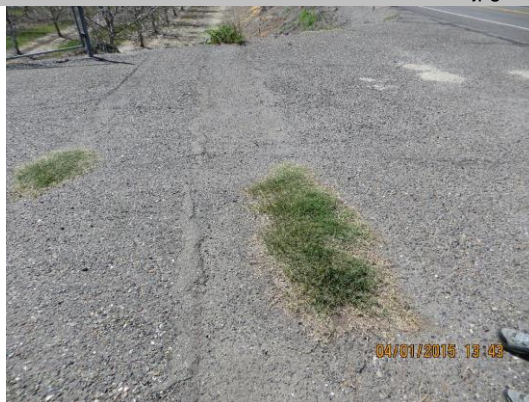
Photo 2 of 2 : UCIP_SP_2018_44185_73607.jpg

Cut in pavement visible at crown good indicator of crossing location.

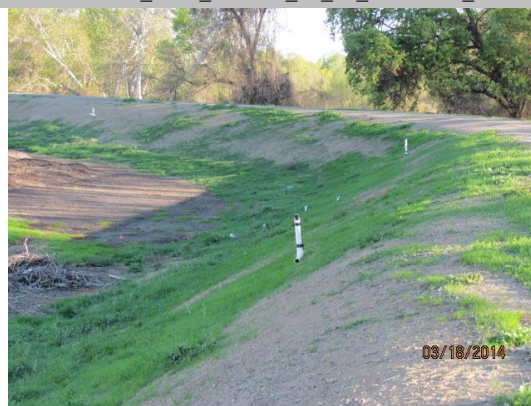
Photo 1 of 2 : SP_2018_LD0002_28_27_20180305_00013.jpg

View of the rodent activity along the landside slope.

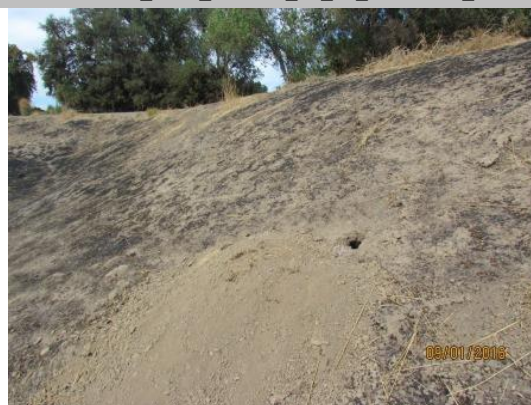
Photo 2 of 2 : SP_2018_LD0002_28_27_20180305_00014.jpg

View of the rodent holes along the landside slope.

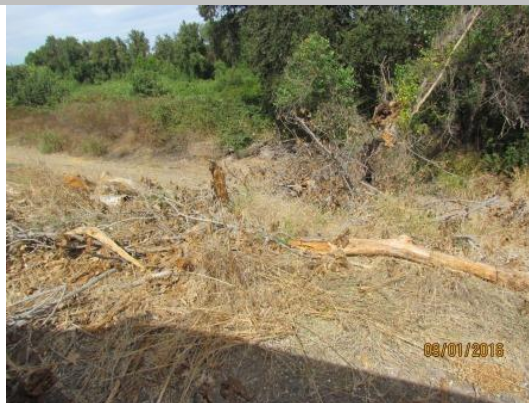
Photo 1 of 2 : SP_2018_LD0002_28_46_20180305_00023.jpg

View of a fallen tree along the waterside slope.

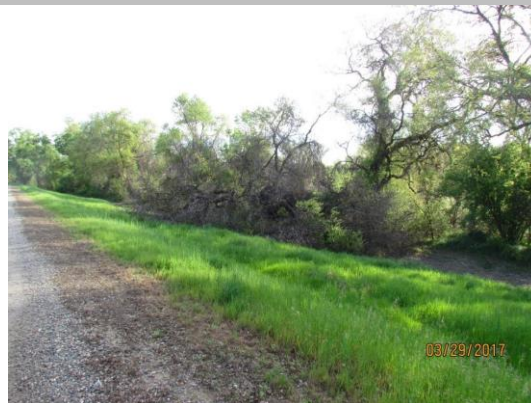
Photo 2 of 2 : SP_2018_LD0002_28_46_20180305_00024.jpg

View of the tree along the waterside slope and toe.

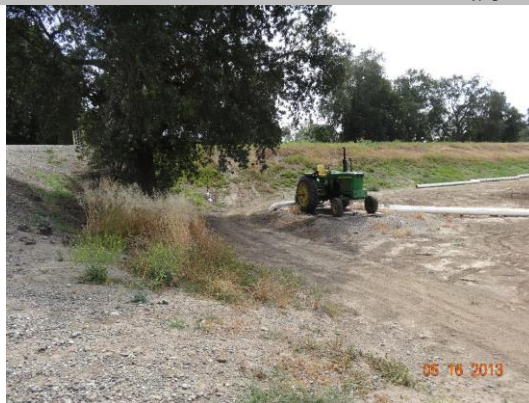
Photo 1 of 3 : UCIP_SP_2018_38178_69502.jpg

View of pump system on landward side located behind tracker.

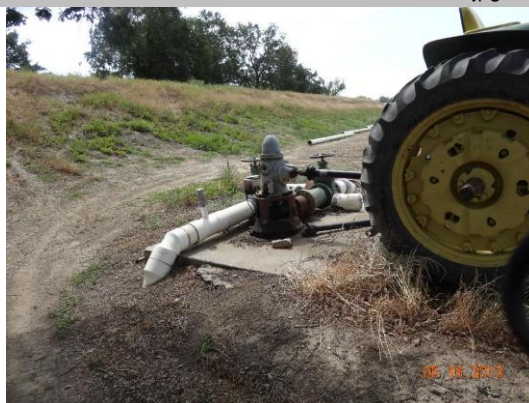
Photo 2 of 3 : UCIP_SP_2018_38178_69501.jpg

Pump system located near landward toe.

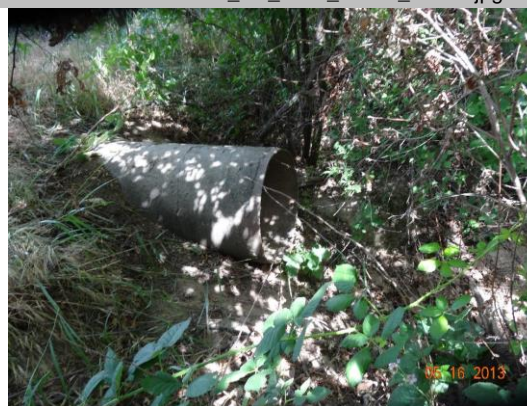
Photo 2 of 3 : UCIP_SP_2018_38182_69533.jpg

Pipe visible on waterward side.

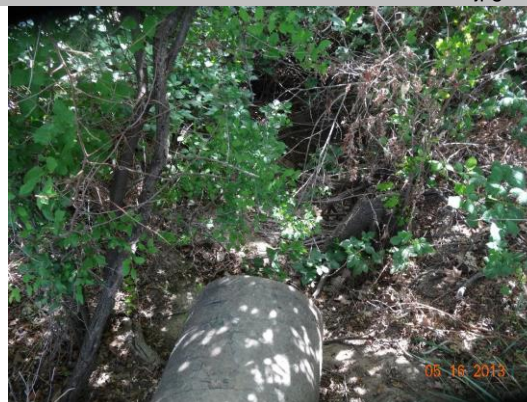
Photo 3 of 3 : UCIP_SP_2018_38182_69541.jpg

View of channel on waterward side.

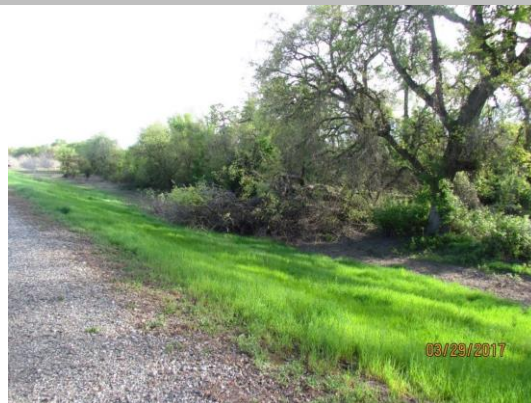
Photo 1 of 1 : SP_2018_LD0002_28_31_20180305_00017.jpg

View of the tree along the waterside slope and toe.

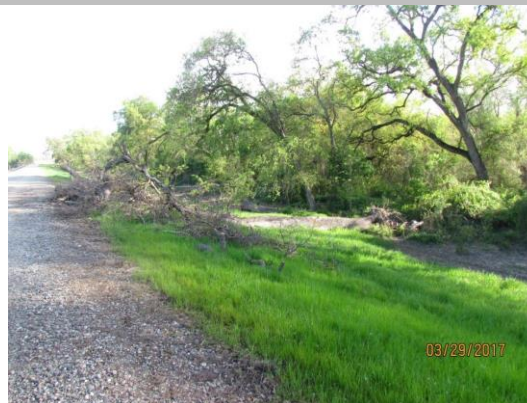
Photo 1 of 1 : SP_2018_LD0002_28_50_20180305_00025.jpg

View of the tree on the water sideslope and toe.

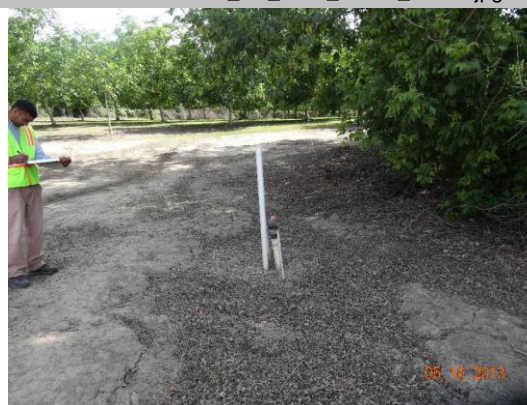
Photo 1 of 3 : UCIP_SP_2018_44188_69544.jpg

3-inch PVC pipe and vent exposed on waterward toe, likely in alignment with this crossing.
